REPORT
HAZARD MITIGATION OPPORTUNITIES
for the

CLIFF WALK
Newport, Rhode Island

Federal Emergency Management Agency

March 1992

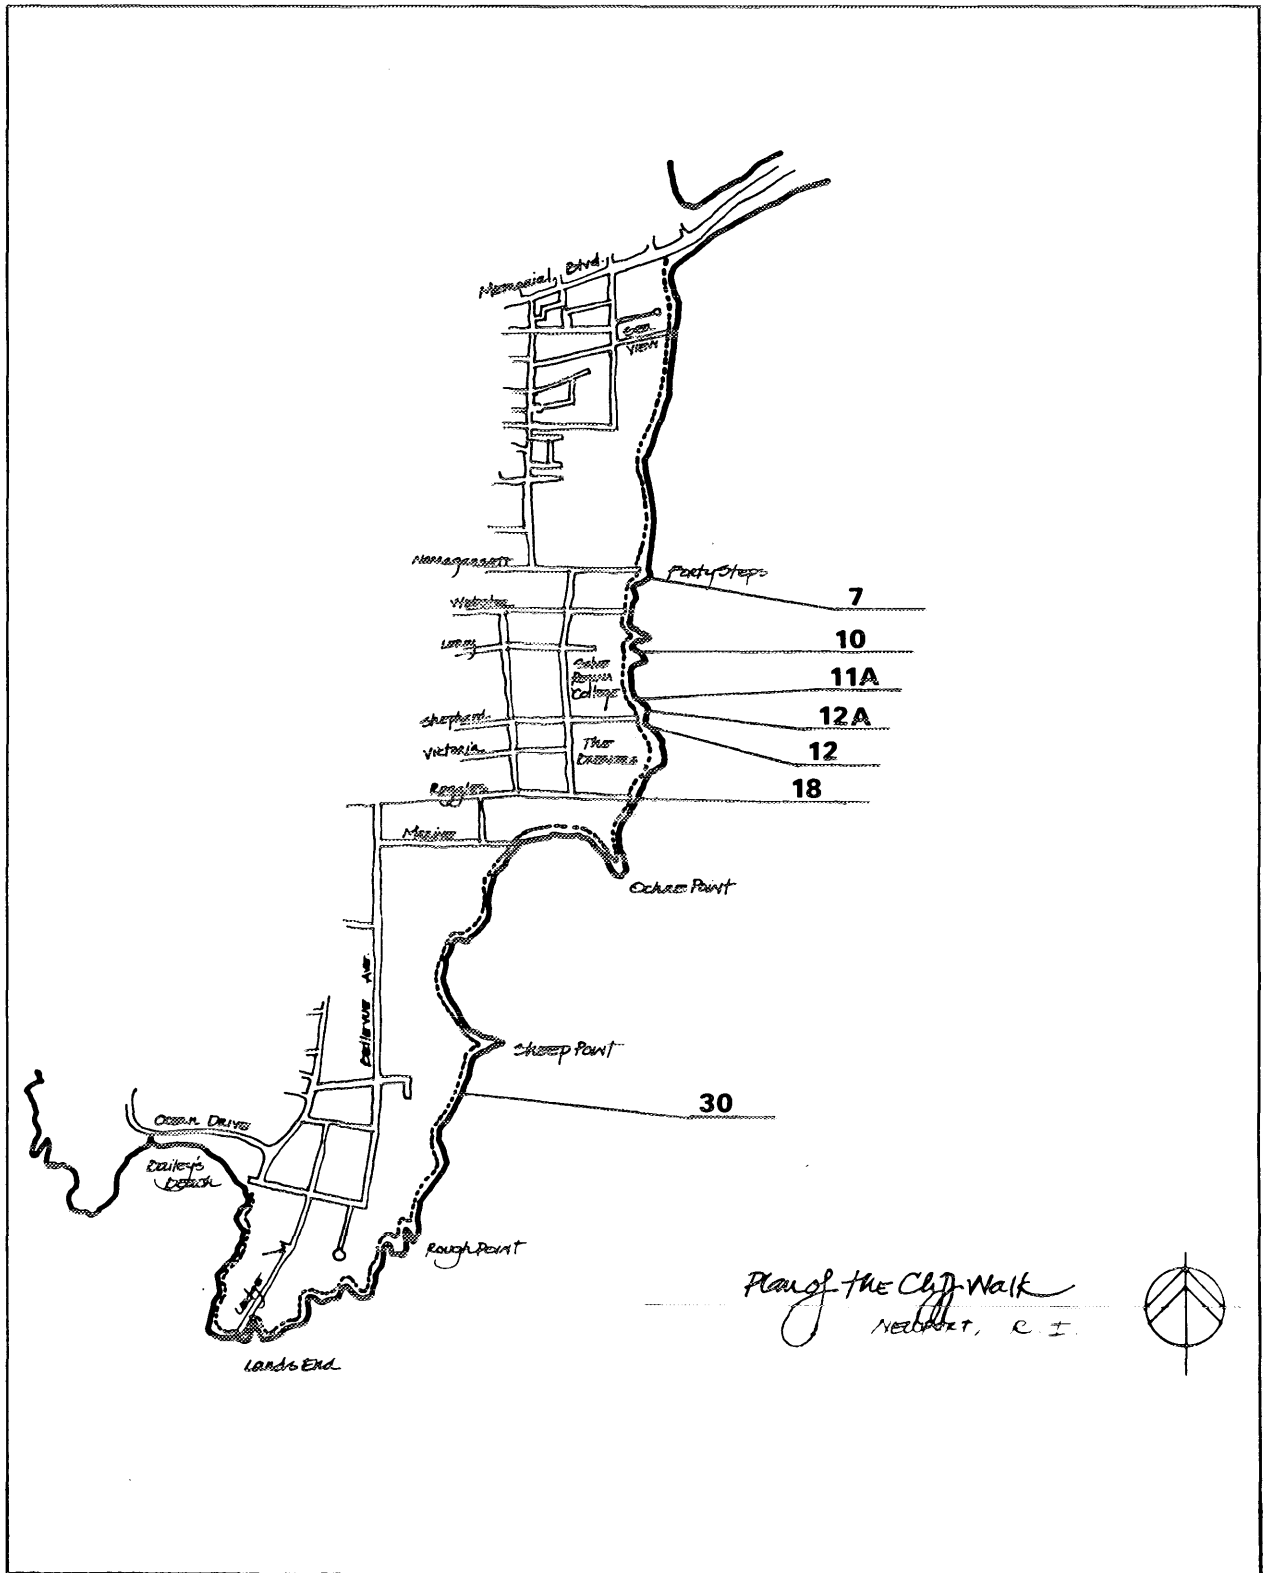
Map 2: Key Structural Repair Opportunities

This site, shown in Views #1 and #2 and Map 2⁸ on the following page, was identified in the 1988 ACOE Report as needing an extension of the existing riprap revetment, and construction of a new concrete wall and fence. Erosion damage to the cliff outcrop shown in View #1 has been continual over time, rather than specifically caused by the August 1991 hurricane. The Walk is located within several feet of the top of this cliff outcrop. It also appears that this outcrop may have a fault line which renders it particularly susceptible to future storm damage. It is likely that future storms could lead to the collapse of this outcrop, threatening the integrity and safety of the Cliff Walk in this area. Accordingly, among the damaged sites ineligible for Public Assistance, this site appears to be of higher priority for attention.

Although comparison of the 1988 ACOE photos with September 1991 photos reveals no substantial amount of additional erosion, this site remains a critical area as identified by the ACOE since the cliff edge is within a few feet of the Walk. The ACOE report recommended installation of a 10 ft. high by 20 ft. long retaining wall to prevent future erosion damage. It also appears that planting of vegetation above such a retaining wall is needed to stabilize the soil below the Walk. Safety fencing has

Both the north and south ends of the existing stone retaining wall which constitutes this site are eroding adjacent to the embankment. The Cliff Walk comes within about 4-6 feet of the eroding south end of this wall. The 1988 ACOE Report recommended that this wall be repointed and repaired.¹¹ As an existing structure, where continued deterioration could result in both damage to the Walk and future costly repair, this site should be given priority for attention. A recent report by the City of Newport recommends fencing, vegetation and drainage improvements for this site.¹²
